# FURNACE BRAZING

## **Four-stroke cylinder head Furnace Brazing**

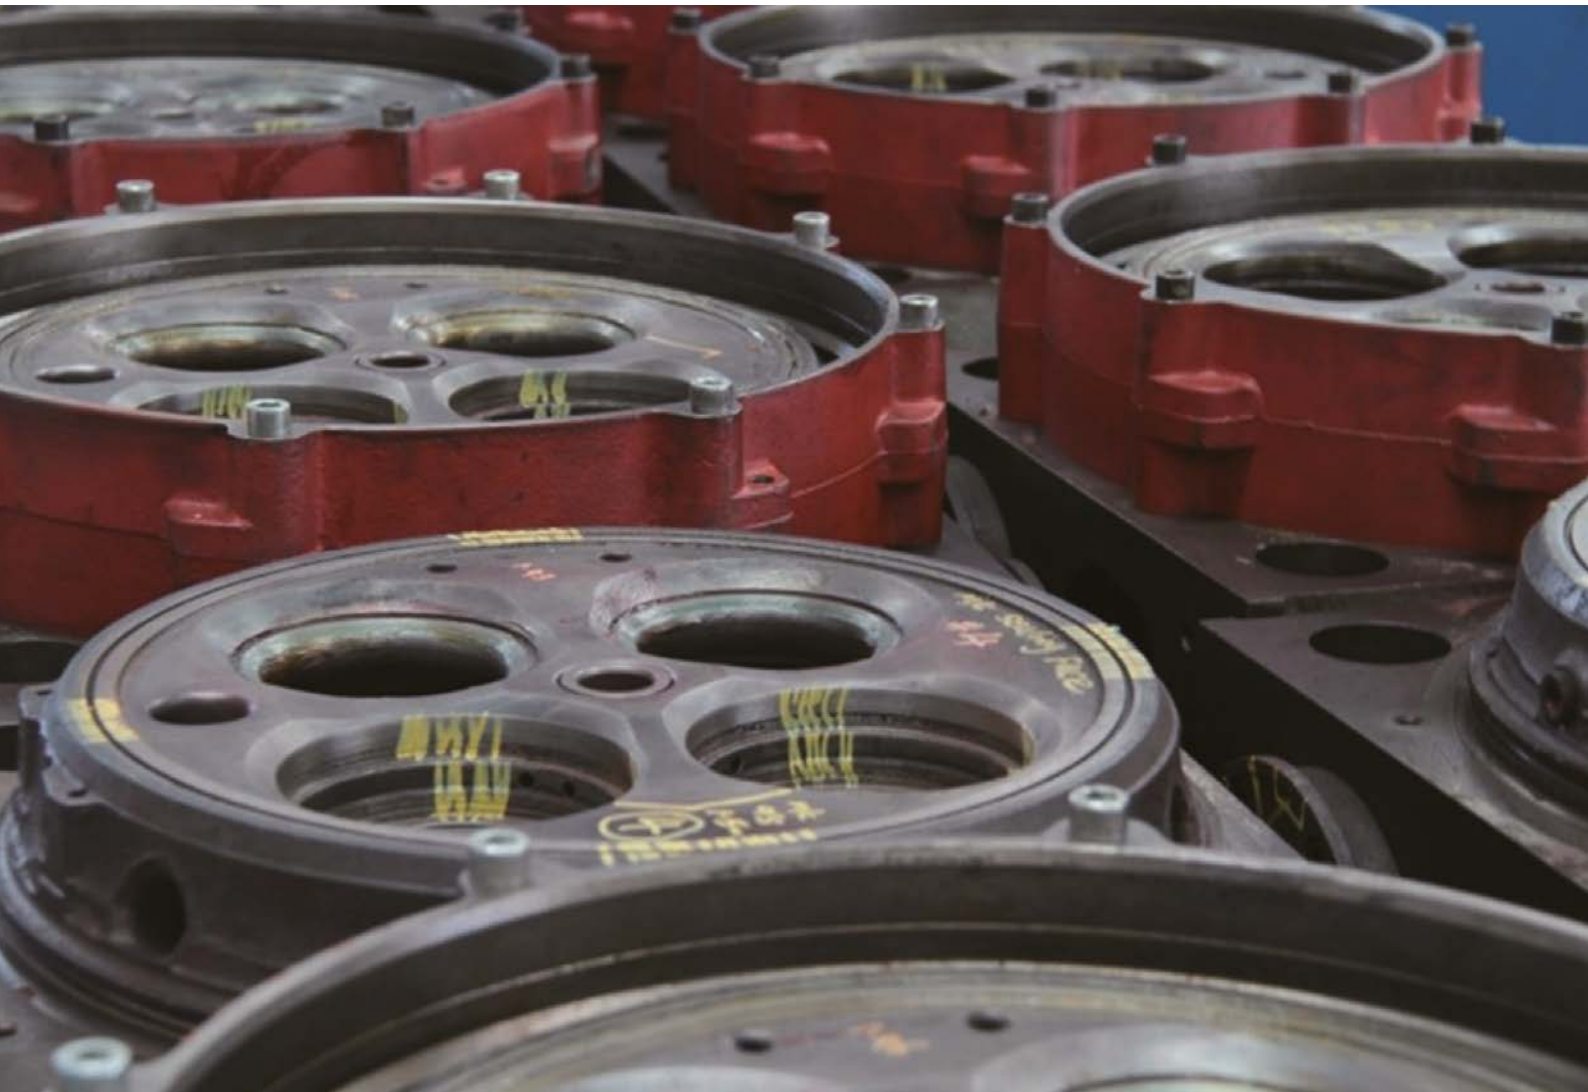
As the name suggests, furnace brazing is done at high temperature in a furnace, where a bonding metal is evenly deposited between the cylinder head and the new rings through capillary suction. This results in an extremely strong and durable bond. An alternative to furnace brazing is laser welding.

On four-stroke cylinder heads, cavitation or corrosion in the exhaust valve seat bore is a fairly common occurrence. If it is severe, then the o-rings may not be able to carry out their function anymore. The consequence is water leaking into the combustion space.

Such corrosion or cavitation can be rectified by machining the valve seat bores and installing over-size valve seats. But as the maximum allowable over-size usually is limited to around +2.00 mm, oversize valve seats may not always solve the problem. In such a case the installation of new rings by furnace brazing can offer a permanent solution.
